TRIPLE TREE
ENGINEERING

Preliminary Engineering Report

Cooke City Water System PER

April 2024

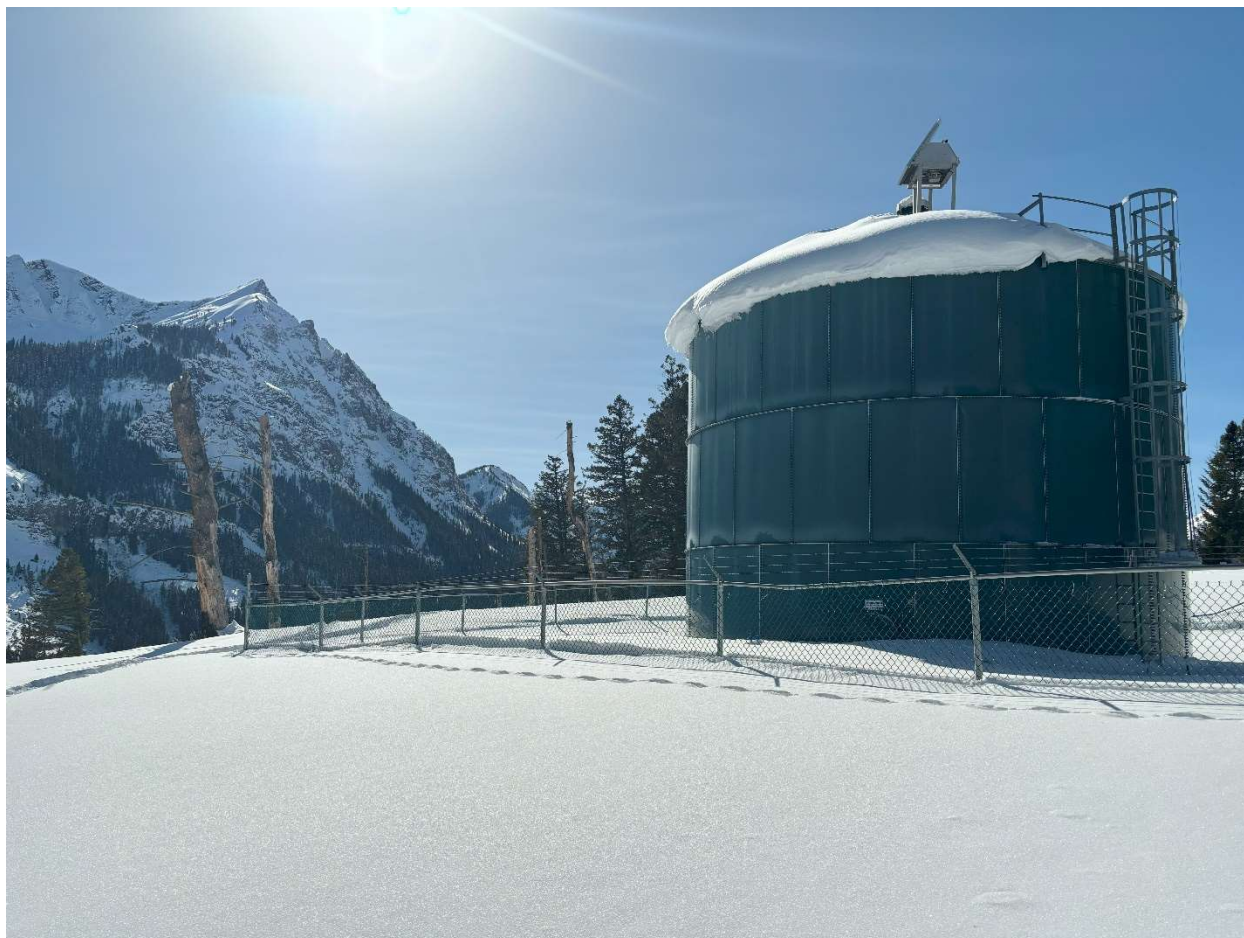
Figure 4 -150,000 Gallon Tank

When the District built a new system in 2010, both of the existing tanks were abandoned and demolished. The 2010 project included installation of a new 150,000 gallon welded steel tank that is still in use today. Per original plans from Great West Engineering, the tank is lined and is supported by a concrete foundation. The tank is fitted with a galvanized steel ladder for access through a locked hatch at the top of the tank. The

ground elevation at the current tank is approximately 7884.5' per the original design plans dated 2010. The tank is approximately 32' high (as measured from the foundation to the edge of the roof) with a 30' diameter. The tank is equipped with an internal mixer that is currently not operational.

As mentioned previously, the 150,000 gallon tank was erected in 2010. The tank's outer structure is currently in good operational condition and is showing no signs of leakage. The concrete foundation and drains are currently in good working order. The tank is equipped with a solar-powered mixer to prevent freezing and stratification of the water in the tank. The mixer broke during the winter of 2022, and is currently inoperable. The Water District is currently in the process of planning to replace and/or fix the existing mixer. The perimeter fence around the existing tank is currently down and in need of repair. Currently, the fence provides no protection from unauthorized access to the tank or vandalism.

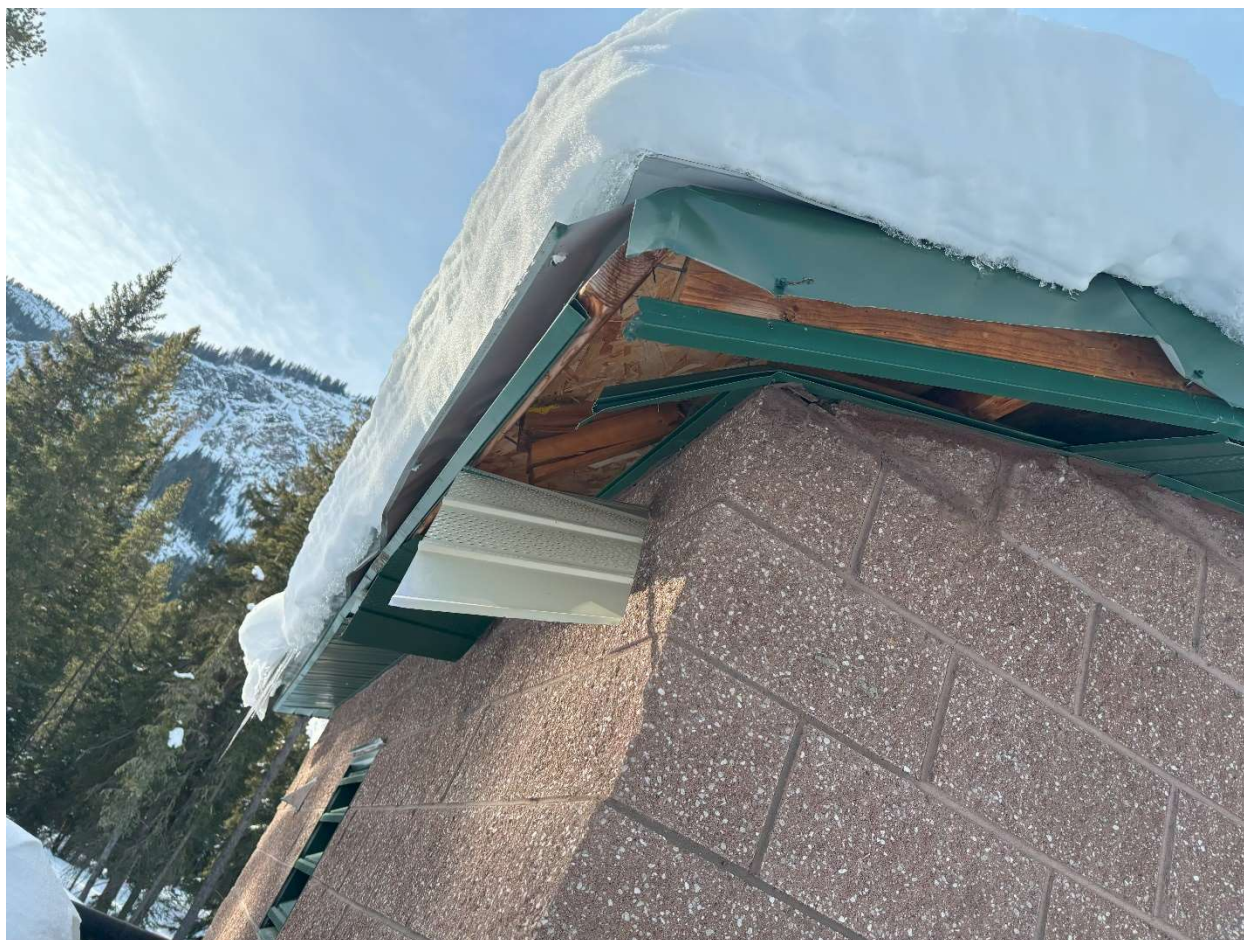
Figure 8 – Failing Well House Roof

The well house roof is currently failing and buckling on the east side of the building. If the roof fails, it could lead to the destruction of thousands of dollars of equipment, loss of supply of water to Cooke City, and possible contamination of the supply system.

The condition of the pump house roof will continue to deteriorate until failure. Roof failure could lead to the destruction of thousands of dollars in electronic controls, loss of supply to the community, and possible contamination of the water supply. The current roof condition does not pose an immediate health and safety concern but could at some point. MT DEQ requires all pumping stations to “be durable construction, fire and weather resistant, and with outward-opening doors;” per DEQ Circular-1 standard 6.2.C. Roof failure would hinder the system from meeting this requirement.

1. Repair and replace portions of the pump house roof and well heads.
2. Repairs to the storage tank mixer.
